Review Paper: Environmental factors affecting Composite Materials

M. Umar, Zaffer M. Khan

Institute of Space Technology, Islamabad,
Pakistan

Keywords: Polymer Matrix Composites (PMCs), Fibre Reinforced Polymer (FRP)

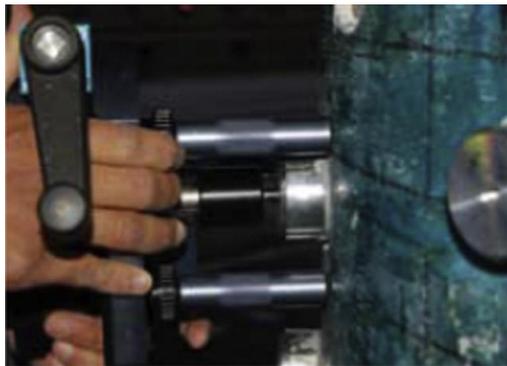
Fig. 5. Moderately destructive technique: The pull-off experiment [4].

Banthia et al. [4] explained an experimental valuation of the bond amongst PMCs and concrete. In Canada, the researchers executed direct tensile pull-off experiments on numerous in-service installations (Fig. 5).

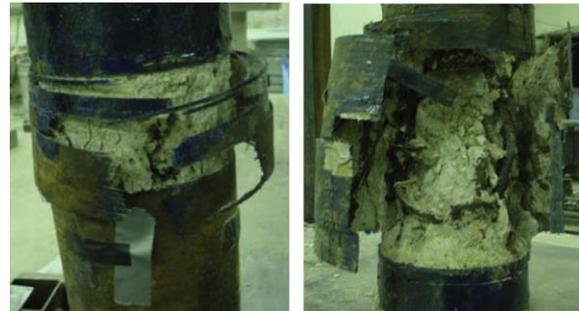
Fig. 6. Damage sites post concentric axial-load analysis: (a) CFRP split devoid of accelerated corrosion (b) Lap joint debonding - CFRP sheets post accelerated corrosion [7].

A methodical paper by Belarbi et al. [7] presented outcomes of an environmental experiment of GFRP- and CFRP-wrapped concrete reinforcement columns (Fig. 6). Environments encompassed cycles of freezing–thawing, cycles of high temperatures, cycles of high humidity, UV radiation, and saline water. The paper also presented evidence from several other researchers as a literature review. Glass fibre reinforced polymer was witnessed to be more sensitive than Carbon fibre reinforced polymer to high temperature cycle damaging with high humidity cycles and Ultraviolet radiation. The GFRP experienced an extraordinary reduction in failure load, but the CFRP seemed practically invulnerable to collective environmental cycles. Cycles of high temperature collectively with cycles of high humidity and Ultraviolet

The columns which were CFRP-wrapped had degradation which was much lesser than the degradation of the columns which were GFRP-wrapped. Moisture was yet again was the primary concern. Baiyasi and Harichandran [12] carried out trials to study the usefulness of employing GFRP and CFRP wraps to reorient corroding columns of concrete. The researchers studied effects of freeze/ thaw, wrapping on the rate of corrosion effects, effects of wet/dry, effects of high temperature resistance to impact, and field employment on corroding sections of FRP wraps. PMCs were tested independently, not connected to concrete samples. There was no noteworthy reduction in mechanical properties under any conditions of exposure. Though, each condition of exposure was tried individually. They had not been cycled. Baiyasi and Harichandran [12] established that damage and minor vehicle impacts do not considerably affect the performance of GFRP or CFRP wraps.
